Test report # PF22005

Client: Parchem Construction Supplies Pty Ltd

Fire resistance tests for wall linear gaps

Test method: AS 1530.4:2014

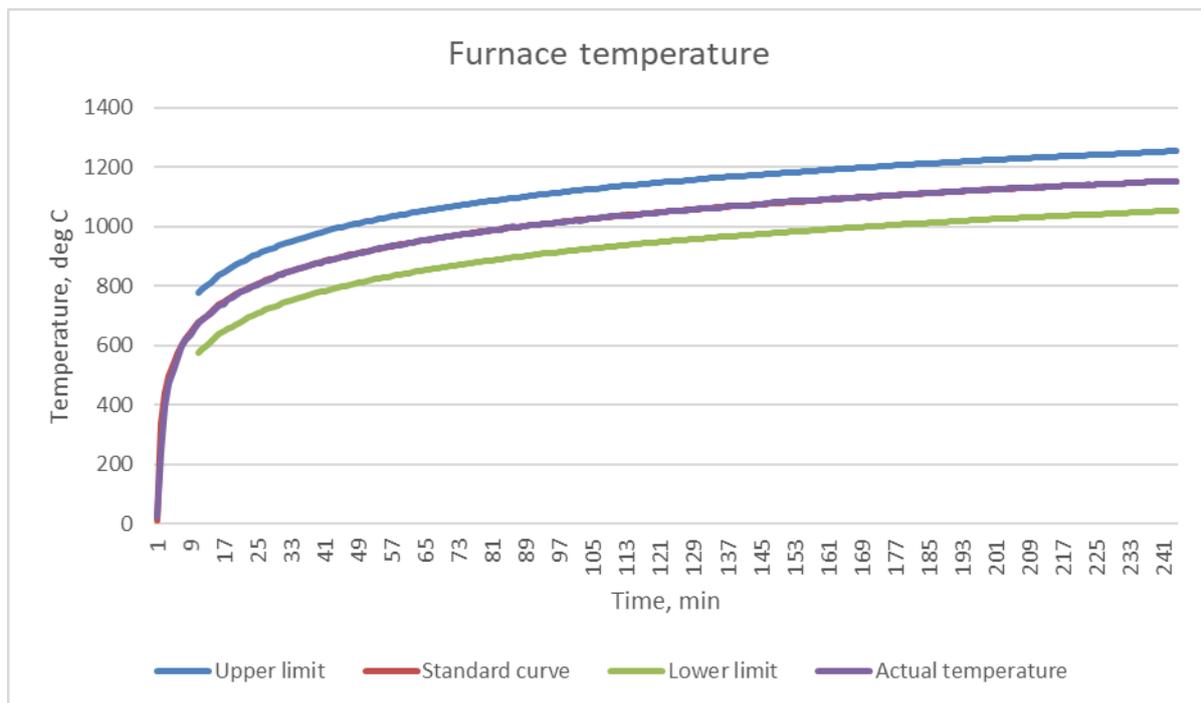
6.1 Furnace Temperature

The furnace was controlled to follow the temperature/time relationship specified in AS 1530.4-2014 as closely as possible.

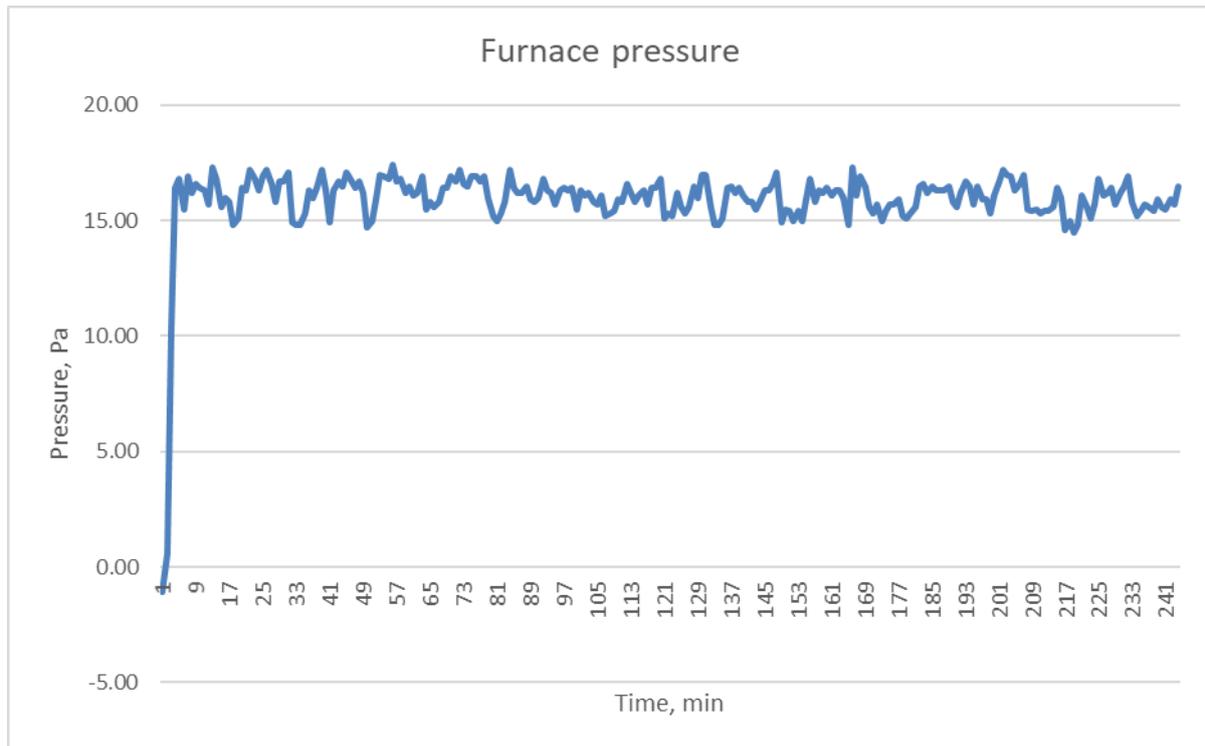
6.3 Pressure Readings

After the first 5 minutes of the test, the furnace pressure was maintained at 16 ± 3 Pa with respect to atmosphere. The probe was located 500mm above the furnace floor.

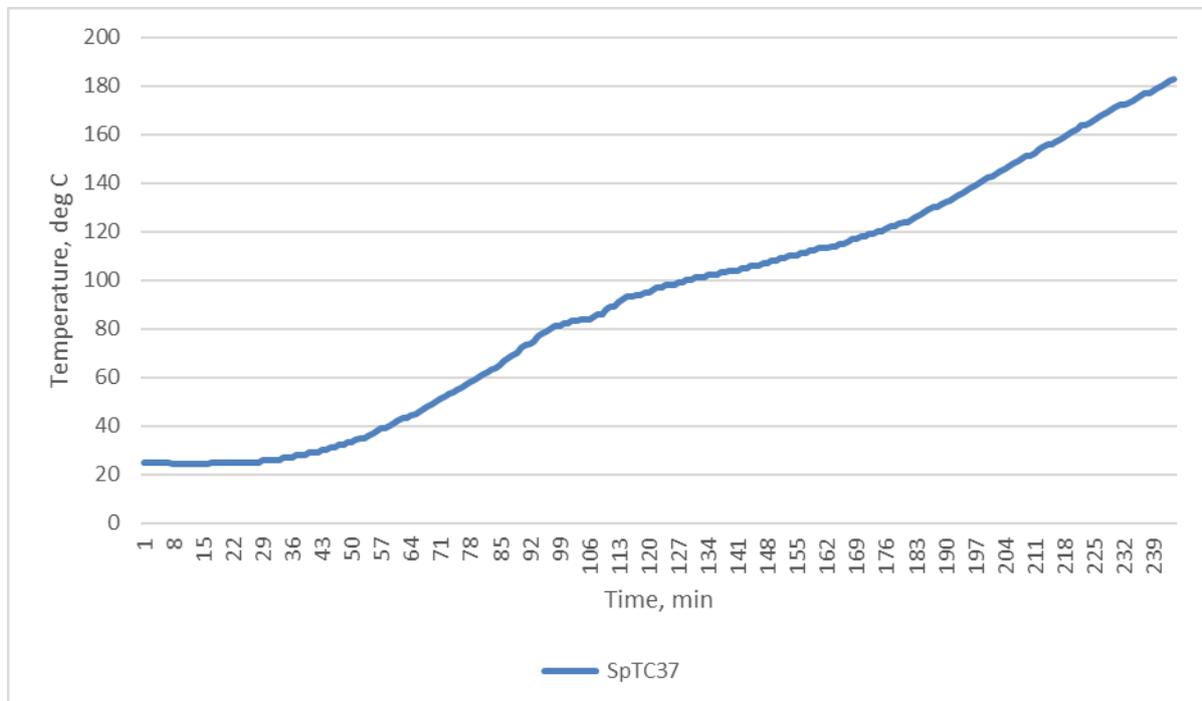
Separating element temperature

Concrete Slab (1.1) was cut into 5 slabs with a width of 210mm (nominal) and a height of 1190mm (nominal). The cut concrete slabs were placed in the refractory frame and fixed using steel saddle clamps (1.3) and drive anchors (4.1). The horizontal spacing between each concrete slab from left to right (unexposed view) was measured to be 30mm, 20mm, 20mm and 20mm. The spacing between outer concrete slabs and the refractory frame was packed using ceramic fibre.

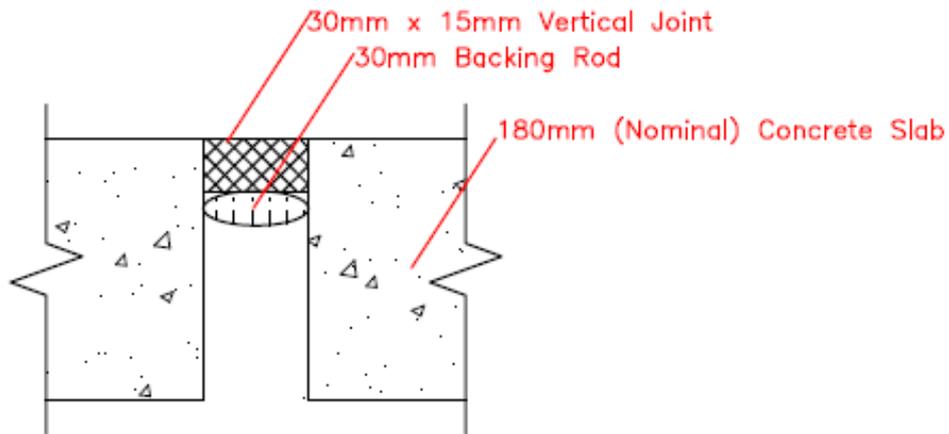
Specimen A

Penetration System		
A	Service	30mm Butt-joined Vertical Linear Joint
	Joint Details	Sealant (3.1)
	Aperture Size	Width/Height (W/H): 30mm x 1200mm
Local Fire-stopping Protection		
	Application	Asymmetrical
	Protection Used	PEF Backing rod (4.2) was pressed into the Concrete Slab (1.2) separating element gap from the unexposed face. PEF rod was recessed 15mm from the surface. Sealant (3.1) was applied on top of the PEF rod, flush with the separating element face, resulting in a 15mm (nominal) depth of sealant along the aperture.

Structural adequacy	Not applicable
Integrity	No failure at 243 min
Insulation	151 min

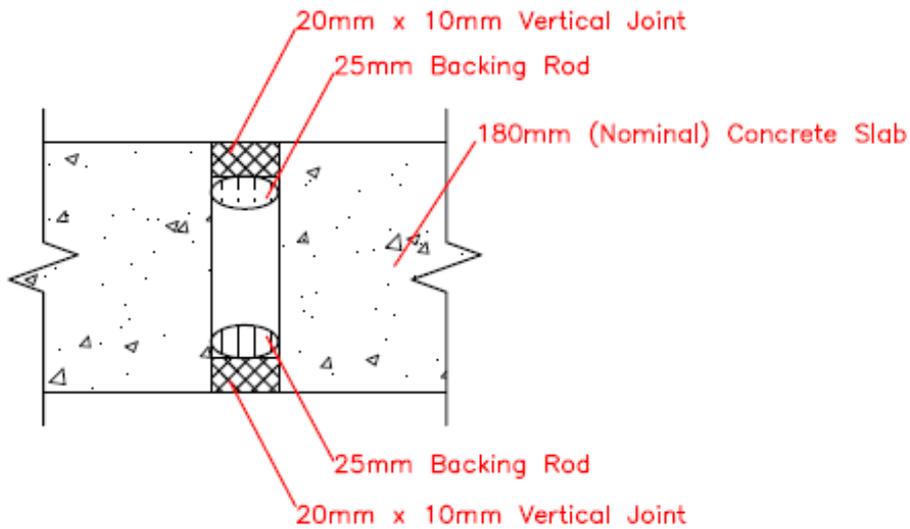
Specimen B

Penetration System		
B	Service	20mm Butt-jointed Vertical Linear Joint
	Joint Details	Sealant (3.1)
	Aperture Size	Width/Height (W/H): 20mm x 1200mm
Local Fire-stopping Protection		
	Application	Symmetrical
	Protection Used	PEF Backing rod (4.2) was pressed into the Concrete Slab (1.2) separating element gap from both faces. PEF rod was recessed 10mm from the surfaces. Sealant (3.1) was applied on top of both PEF rods, flush with the separating element faces, resulting in a 10mm (nominal) depth of sealant along each aperture.

Structural adequacy	Not applicable
Integrity	No failure at 243 min
Insulation	No failure at 243 min

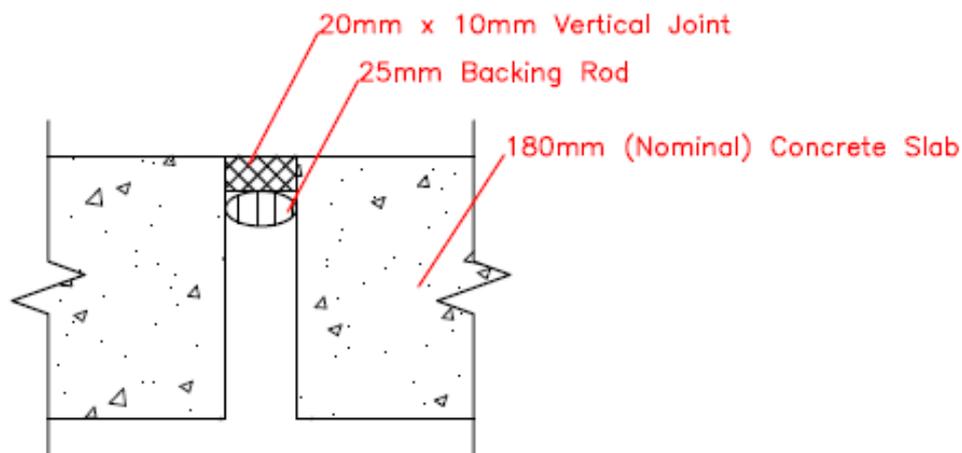
Specimen C

Penetration System		
C	Service	20mm Butt-joined Vertical Linear Joint
	Joint Details	Sealant (3.1)
	Aperture Size	Width/Height (W/H): 20mm x 1200mm
	Local Fire-stopping Protection	
	Application	Asymmetrical
	Protection Used	PEF Backing rod (4.2) was pressed into the Concrete Slab (1.2) separating element gap from the unexposed face. PEF rod was recessed 10mm from the surface. Sealant (3.1) was applied on top of the PEF rod, flush with the separating element face, resulting in a 10mm (nominal) depth of sealant along the aperture.

Structural adequacy	Not applicable
Integrity	No failure at 243 min
Insulation	151 min

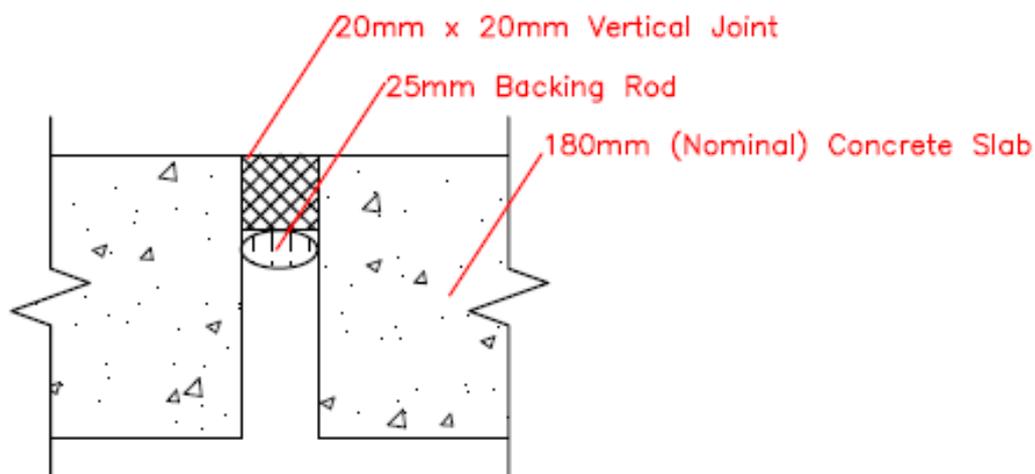
Specimen D

Penetration System		
D	Service	20mm Butt-joined Vertical Linear Joint
	Joint Details	Sealant (3.1)
	Aperture Size	Width/Height (W/H): 20mm x 1200mm
	Local Fire-stopping Protection	
	Application	Asymmetrical
	Protection Used	PEF Backing rod (4.2) was pressed into the Concrete Slab (1.2) separating element gap from the unexposed face. PEF rod was recessed 20mm from the surface. Sealant (3.1) was applied on top of the PEF rod, flush with the separating element face, resulting in a 20mm (nominal) depth of sealant along the aperture.

Structural adequacy	Not applicable
Integrity	No failure at 243 min
Insulation	203 min
